INTRODUCTION	Page 1
Listed Status and Grant Assistance	Page 1
Orientation and Location	Page 1
Limitations of the Survey	Page 1
Methodology	Page 2
Historical Development	Page 2
Description	Page 2
EXECUTIVE SUMMARY	Page 3
CONDITION REPORT	Page 4
Exterior	Page 4
Interior	Page 11
Appendix A - Plans	
Appendix B - Elevations

This condition report on Chambre House (Photo 01), in Slieve Gullion Forest Park, has been commissioned by Newry and Mourne District Council. The purpose of the report is to provide an assessment of the condition of the external and internal fabric of the building and to make recommendations for possible future refurbishment. The inspection was carried out on Friday 24 January 2014 by Alastair Coey, a Grade One conservation architect, and Adrian Curran, a senior architectural technologist with extensive experience of inspecting listed buildings. The weather conditions were poor with persistent rain, cold and calm.

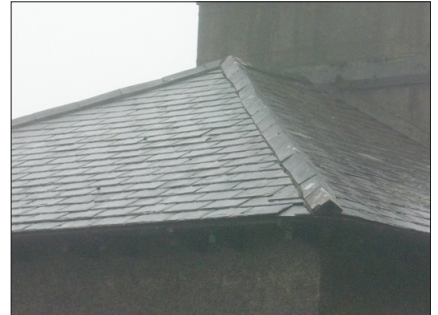
- Slating - 1 no. missing slate and 1 no. slipped slate to north-west corner of roofslope RS04 otherwise the slating appears in good condition throughout (Photos 04 and 05).
- Ridge tiles - Ridge and hipped tiles are disturbed in places otherwise ridge tiles appear in good condition throughout.

Photo 04. Missing slate to roofslope RS04

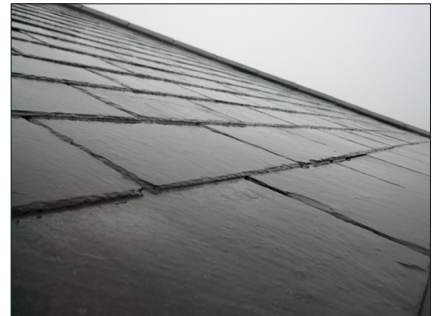
Photo 05. Slating in good condition

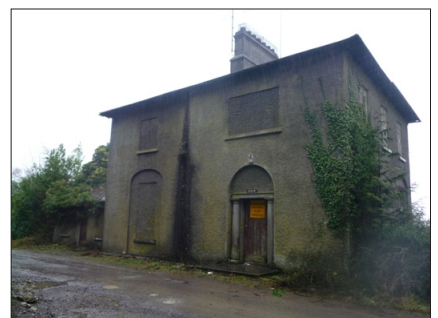
Rough-cast render on rubble granite walling. Ashlar granite chamfered plinth band. Granite doorcase consisting of granite lintel entablature supported on granite Doric columns set within roughcast rendered recessed archway. All window openings blocked up and rendered over with cementacious rough-cast render. Granite sills. (Photo 06)

Photo 06. West elevation

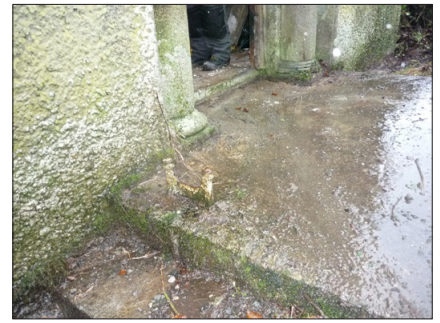
- Render - Inappropriate cementacious render applied to walling and blocked up window openings. Some areas of detachment from background.
- Plinth - Plinth heavily soiled and partially buried below ground. Existing ground levels raised considerably.
- Sills - Reasonable condition.
- Door surround to D101- Heavily soiled otherwise in reasonable condition.
- Steps - Raised stone step. Worn, otherwise reasonable condition. Second set of steps located below ground level.
- Foot scraper - Paint on metal foot scraper housed in stone slab, reasonable condition (Photo 07).

Photo 07. Foot scraper

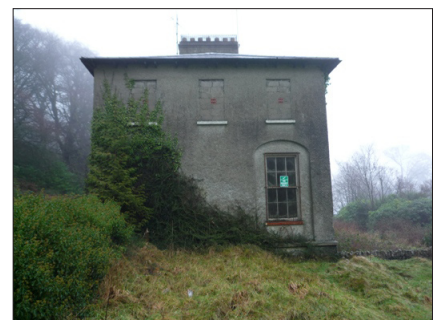
Rough-cast render on rubble granite walling. Ashlar granite chamfered plinth band. All window openings blocked up with concrete blockwork with exception of single ground floor window to east end of elevation. Granite sills. (Photo 08)

Photo 08. South elevation

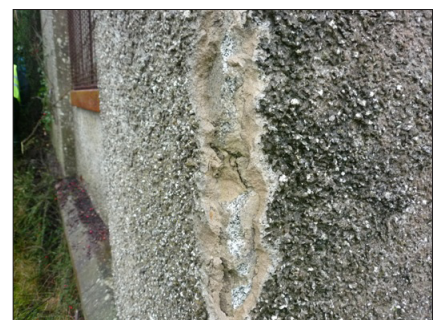
- Render - Inappropriate cementacious render applied to walling. Some damage to east corner exposing underlying rubble granite walling (Photo 09). Heavy vegetation growth to west end of elevation.
- Plinth - Heavily soiled otherwise in reasonable condition.
- Sills - Reasonable condition.

Photo 09. Underlying granite walling

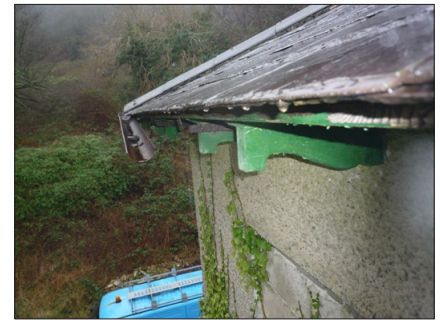
- Gutters - Very poor condition. Section of gutter hanging from eaves .
- Downpipes - None.

Photo 10. Missing section of gutter

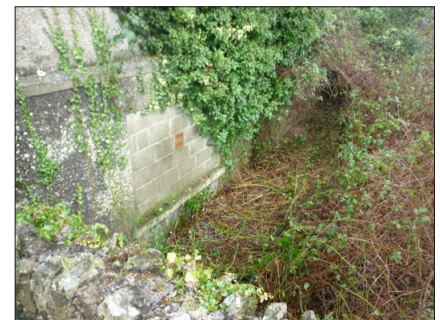
Rough-cast render on rubble granite walling. Ashlar granite chamfered plinth band. All window openings blocked up with concrete blockwork. Basement area spanning full width of elevation flanked by two stone walls. (Photo 11) Granite sills.

Photo 11. Basement area to east elevation

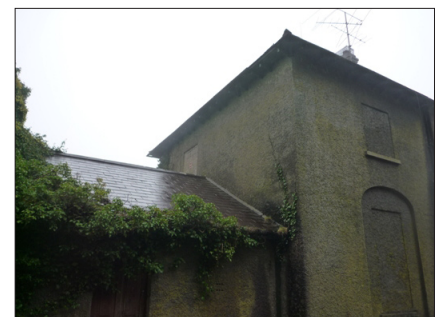
Photo 12. North elevation

- Render - Inappropriate cementacious render applied to walling. Extensive vegetation growth to east end of elevation.
- Sills - Reasonable condition.

- Gutters - Very poor condition. Section of gutter missing to west end.

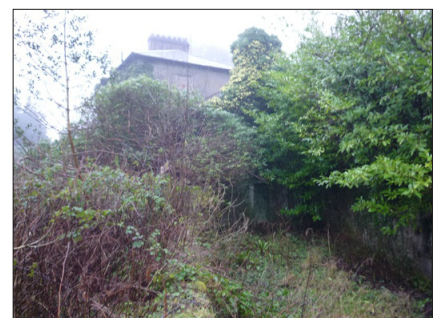
Photo 15. Barely visible north elevation of single storey extension elevation

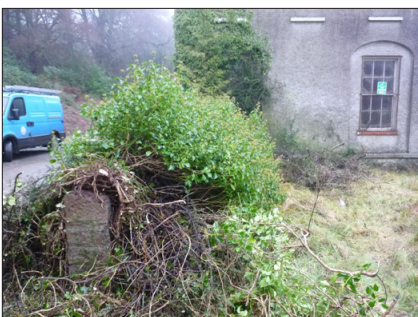
- Boundary wall to roadside - Low level exposed rubble stonework wall abutting west end of south elevation extending southwards along roadside for approximately 9840mm, heavily overgrown (Photo 18).
- Basement walls - Exposed rubble stonework wall abutting south end of west elevation extending eastwards for approximately 4185mm incorporating steps. Steep sided ground to basement area possibly indicating infill or subsided material (Photo 19).
- Walling to north of main house - A tall boundary wall extends beyond the single-storey extension retaining the roadside on the west side and a series of outbuildings in ruinous state on the east side, forming an enclosed yard.

Photo 18. Boundary wall to roadside

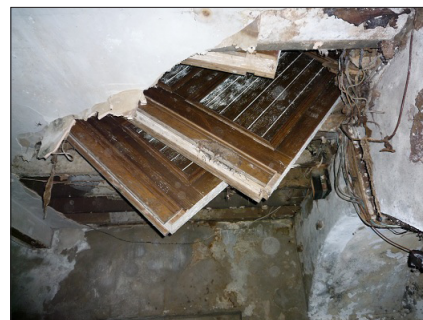
- Floor - Brick and square tile terracotta tile floor, uneven, accumulation of debris, poor condition. Widespread dampness.
- Walls - Plaster on solid background to all walls, extensive efflorescence and deterioration of surface.
- Ceiling - Plasterboard on timber floor joists, partial collapse in several locations (Photo 20). Dry rot fruiting bodies along north section to west of chimney breast. Plasterboard encased steel beam spanning east-west between east wall and free standing pier continuing to west side into west wall.

Photo 20. Collapsed ceiling room R001

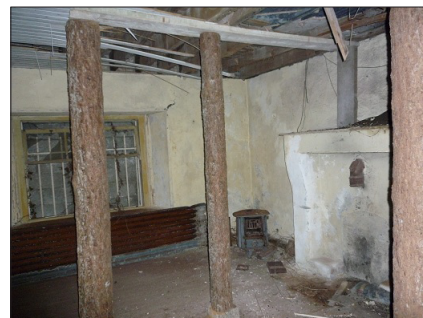
- Floor - Timber boards spanning north-south. Extensive dust and debris on surface, some collapse to south side probably all in poor condition. Five no tree trunks used to prop ground floor (Photo 21).

Photo 21. Tree trunks used to prop floor

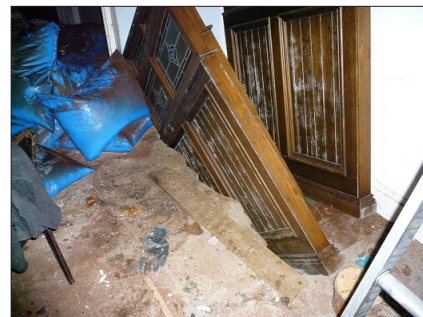
- Floor - Lino on timber floor, substantial collapse in north-east corner (Photo 24), debris and timber baulks in south-west corner, very poor condition.

Photo 24. Collapsed floor

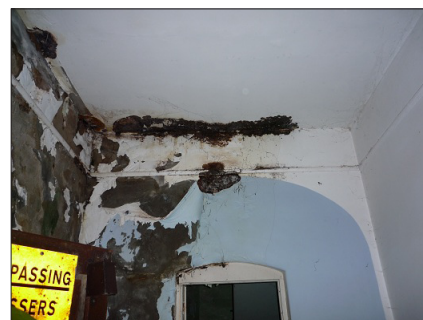
- Ceiling - Paint on plasterboard on ceiling joists, dry rot fruiting bodies to north end (Photo 25), generally poor condition.
- Window to south W102 - 6/6 painted timber sash. Painted timber splayed linings and horizontal board below sill, moulded architrave, average condition.

Photo 25. Dry rot fruiting bodies

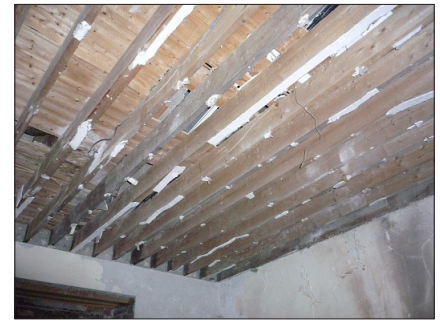
- Ceiling - Paint on plasterboard on ceiling joists, partially collapsed (Photo 27)
- Door - Previously described.
- Window W105 - Window case removed, brick reveals evident, splayed. Stone sill. Window blocked with concrete blockwork.
- Fireplace - South wall. Original fireplace opening remains but fireplace removed.

Photo 27. Collapsed ceiling plaster

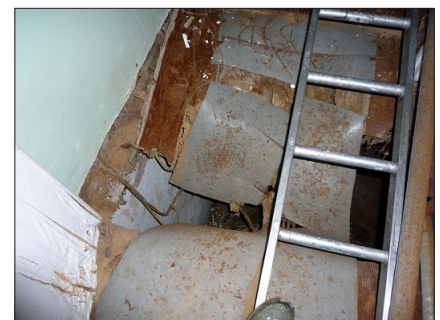
- Floor - Timber T&G boarding spanning north-south, extensive dry rot to west side (Photo 28), very poor condition.
- Walls - Paint on plaster on stud partitions, poor condition.
- Ceiling - Paint on plasterboard on ceiling joists, poor condition.

Photo 28. Collapsed floor caused by dry rot

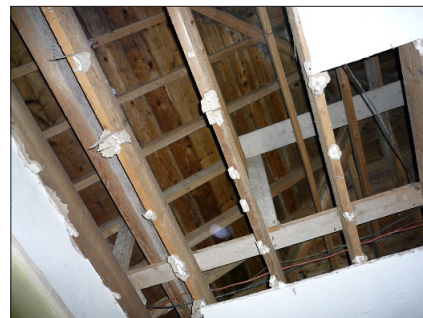
Photo 29. Collapsed ceiling

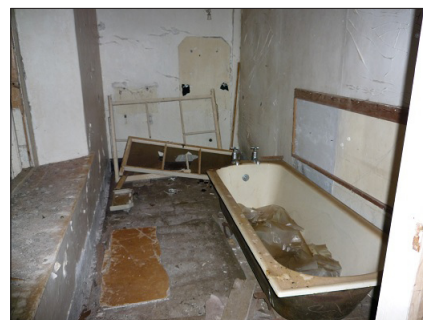
- Floor - T&G timber boards spanning north-south, extensive debris on floor, some boards removed, poor condition (Photo 30).
- Walls - North wall paint on plaster on solid background, extensive flaking and crazing, very poor condition. East wall paint on plaster on solid background, extensive flaking and crazing, very poor condition. South wall paint on plasterboard on stud background, extensive flaking of paint, plasterboard bowing at east end, very poor condition. West

Photo 30. Bathroom in poor condition

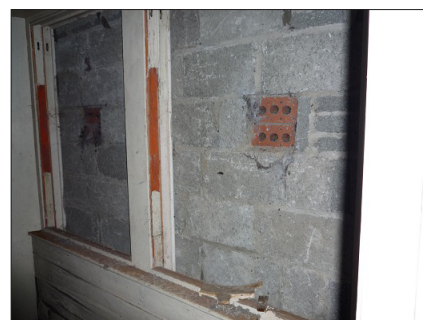
Photo 31. Blocked up windows

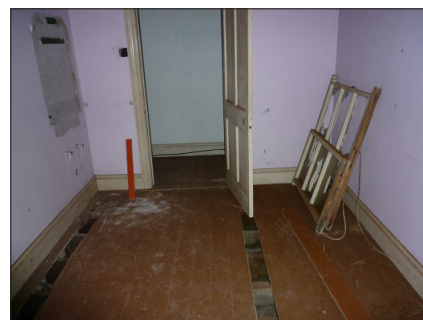
- Floor - T&G timber boards fixed north-south. Two boards lifted (Photo 23), extensive dry rot spores on surface of floor.
- Walls - North, east and west walls paint on plasterboard, poor condition. South wall paint on plaster on solid background, average condition.
- Ceiling - Paint on plasterboard on ceiling joists, poor condition.
- Window W204 - Blocked up. Sashes removed, painted timber linings and architraves, average condition.
- Door D206 - Painted timber four-panelled door, ironmongery missing, average condition.

Photo 32. Floor boards lifted in room R206

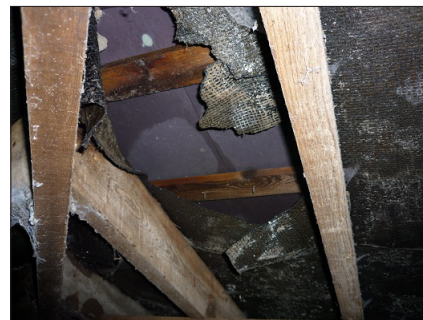
Photo 33. Decayed sarking felt
