# Strangford Lough Eco Mooring Seagrass Survey 2025

Report Update 2025. Prepared for Newry, Mourne and Down District Council  
(NMDDC)

Cuan Marine Services Ltd.

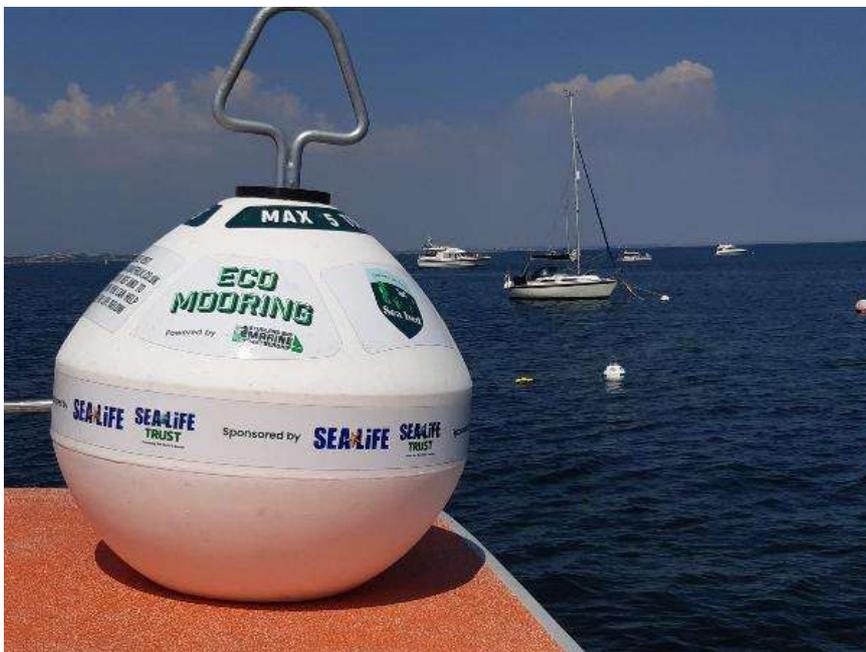
Figure 2. Studland Bay community mooring buoy sites have reduced the incidents of unchecked anchoring in the conservation zone.

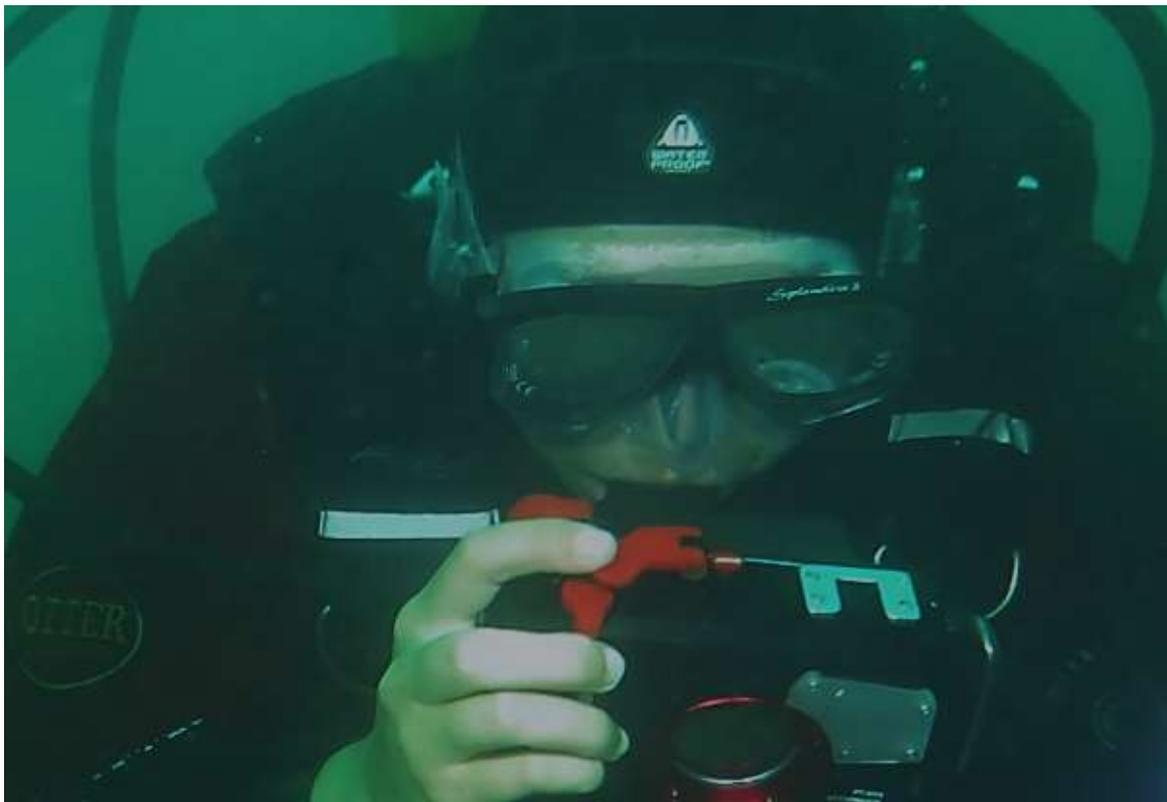
Figure. 6 QUB taxonomist R. Bajko collecting species images at Stirling AMS.

The Stirling© AMS is now located at the edge of the Ballyhenry seagrass meadow, between 6 and 8 metres deep. This depth marks the highest point where *Zostera marina* seagrass grows best. Evaluating the Stirling© system at the shallower Seaflex© site is recommended to allow for a direct comparison of the two AMS models. Such an approach would enhance confidence in the suitability of Stirling© deployments across varying depths and environmental conditions.

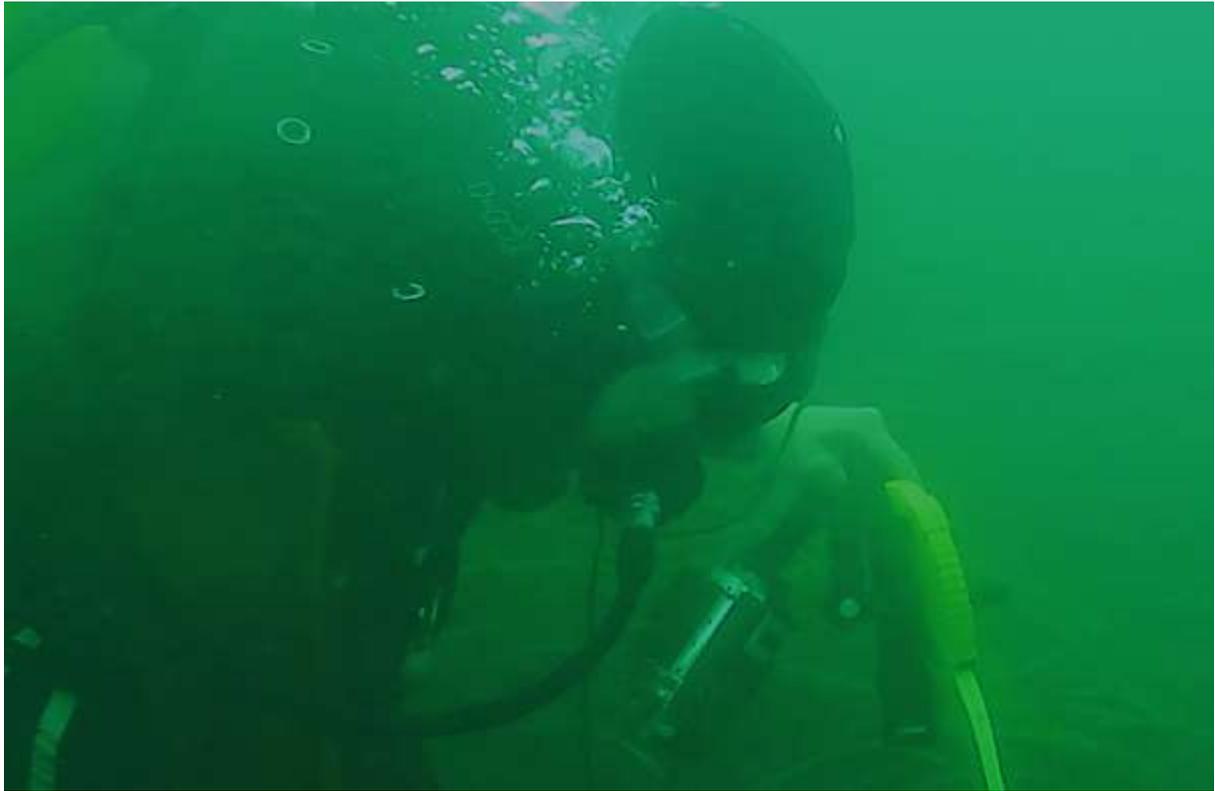
Figure. 6 Laying the transect line at the Seaflex © AMS.

Divers conducted an inspection of the Seaflex© at coordinates N 54° 23.295'; W 005° 33.751' AMS, reaching a maximum depth of 3.6 meters. The system was found to be in optimal working condition. Seagrass coverage remained dense and uninterrupted from the mooring block to the perimeter of the survey plot.

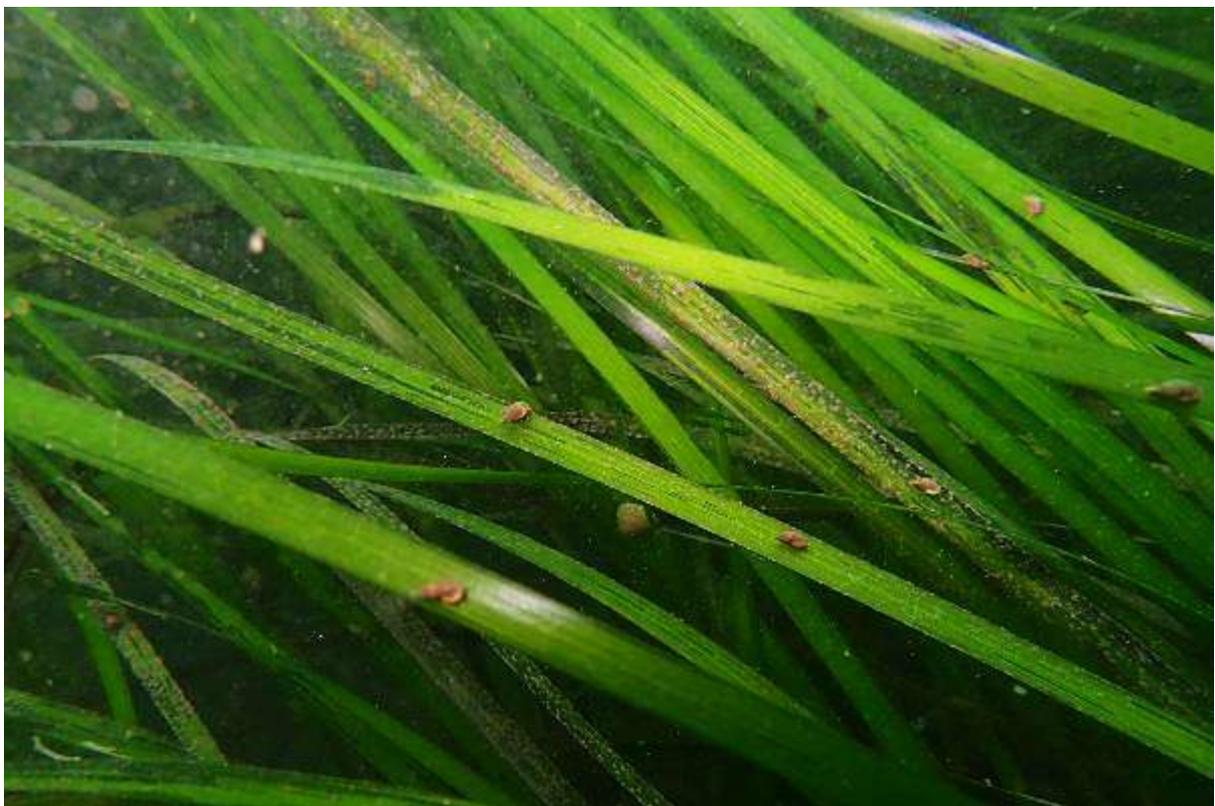
Figure. 7 Gastropods grazing on seagrass blades at the Seaflex© AMS site.

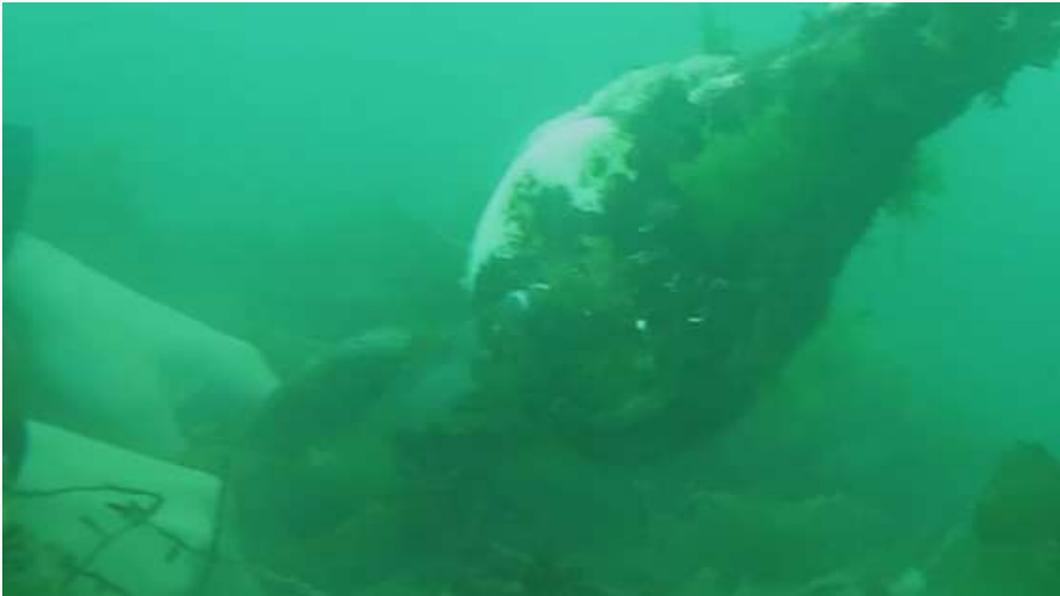
Figure 12. Seaflex© mooring block attachment secure and in good condition.

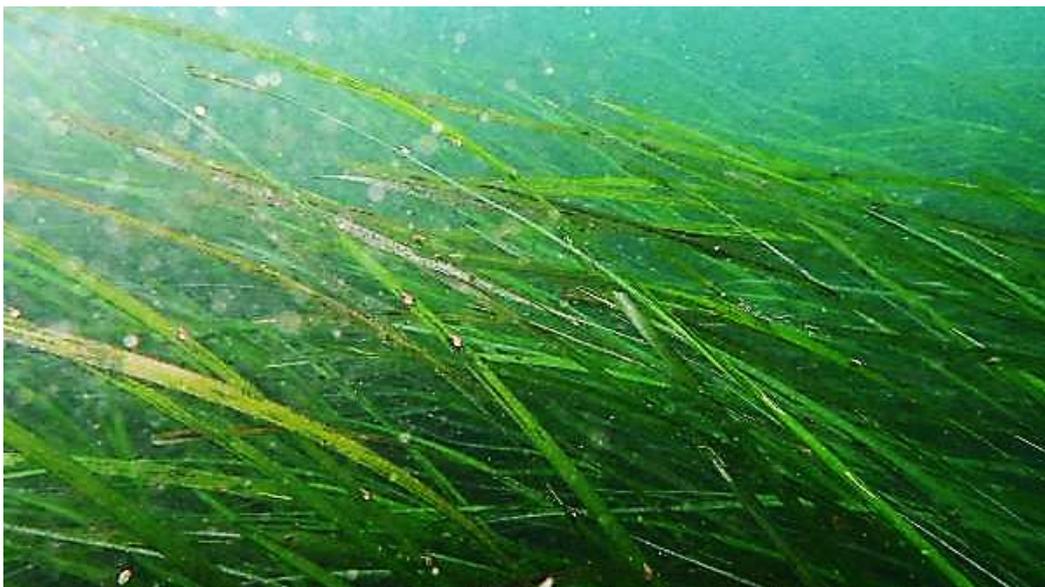
Figure 13. Thick seagrass coverage throughout the Seaflex© site.
