INTRODUCTION	Page 1
Listed Status and Grant Assistance	Page 1
Orientation and Location	Page 1
Limitations of the Survey	Page 1
Methodology	Page 2
Historical Development	Page 2
Description	Page 2
EXECUTIVE SUMMARY	Page 3
CONDITION REPORT	Page 4
Exterior	Page 4
Interior	Page 11
Appendix A - Plans	
Appendix B - Elevations

This condition report on Chambre House (Photo 01), in Slieve Gullion Forest Park, has been commissioned by Newry and Mourne District Council. The purpose of the report is to provide an assessment of the condition of the external and internal fabric of the building and to make recommendations for possible future refurbishment. The inspection was carried out on Friday 24 January 2014 by Alastair Coey, a Grade One conservation architect, and Adrian Curran, a senior architectural technologist with extensive experience of inspecting listed buildings. The weather conditions were poor with persistent rain, cold and calm.

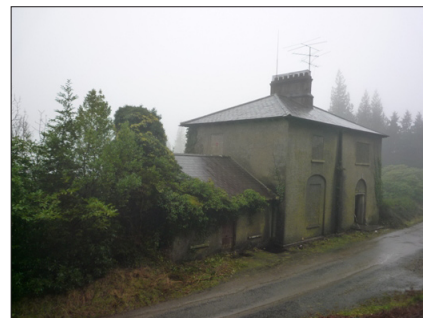
Photo 01. Aspect view from North-west

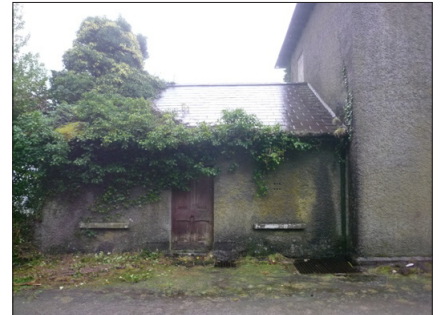
Rough-cast render. Window opening blocked up with concrete blockwork and rendered over flush with wall. Granite sills. (Photo 13)

Photo 13. West elevation of single storey

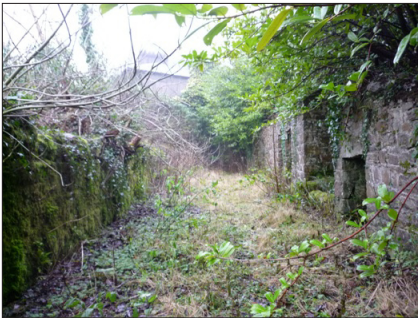
Exposed rubble stone walling with timber lintels to door and window openings. (Photos 16 and 17)

Photo 16. Outbuildings viewed from north

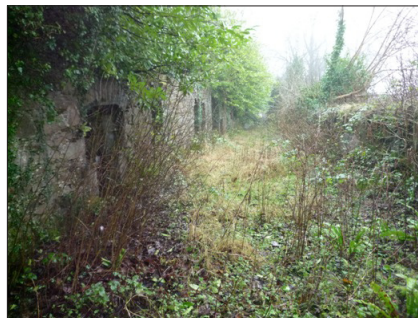
Photo 17. Outbuildings viewed from south

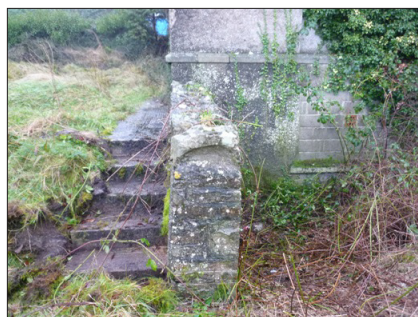
- Boundary wall to roadside - Low level exposed rubble stonework wall abutting west end of south elevation extending southwards along roadside for approximately 9840mm, heavily overgrown (Photo 18).
- Basement walls - Exposed rubble stonework wall abutting south end of west elevation extending eastwards for approximately 4185mm incorporating steps. Steep sided ground to basement area possibly indicating infill or subsided material (Photo 19).
- Walling to north of main house - A tall boundary wall extends beyond the single-storey extension retaining the roadside on the west side and a series of outbuildings in ruinous state on the east side, forming an enclosed yard.

Photo 19. Basement wall

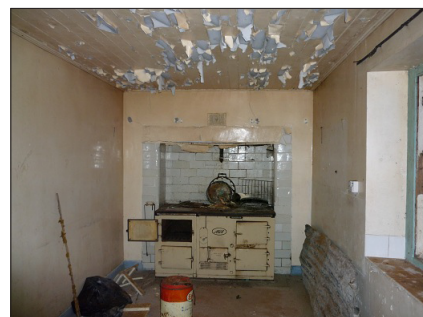
- Floor - Terrazzo floor and coved skirting, reasonable condition.
- Walls - Paint on plaster on solid background to all walls. Flaking widespread, otherwise reasonable condition. Tiles sills to windows.
- Ceiling - T&G sheeting spanning north-south, extensive flaking and falling away of paintwork, poor condition.
- Door - Paint timber four-panelled door, stuck mouldings, ironmongery removed, poor condition.
- Aga cooker - In recess on north wall (Photo 22) with tiling around opening, bull-nosed at corners. Steel lintel sagging.
- Kitchen unit to south wall - Very poor condition.

Photo 22. Aga cooker

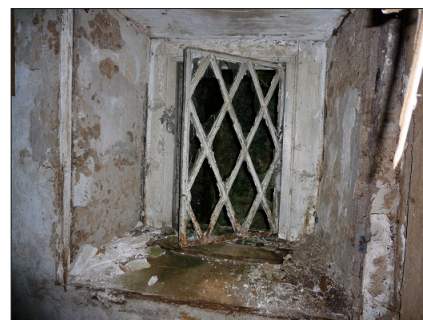
- Floor - Not visible below debris.
- Walls - Paint on plaster on solid background, very poor condition.
- Ceiling - Painted timber T&G sheeting spanning north-south, extensive collapse as result of dry rot, very poor condition.
- Window - Cast iron lattice window (Photo 23) in west wall hinged to north side opening into area, painted plaster reveals, very poor condition. Timber lintel over, very poor condition.

Photo 23 Cast-iron lattice window

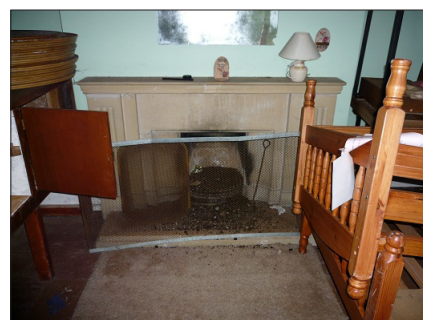
- Floor - Timber boards spanning east-west. Extensive dry rot affecting north-west corner, floorboards deteriorated to collapse although joists appear sound. Carpet on floor to office area.
- Walls - Paint on plaster on solid background to north wall, average condition. East wall paint on plaster on solid background, extensive damp staining, poor condition. South wall paint on plaster on solid background, extensive damp staining, poor condition. West wall paint on plaster on solid single brick thick masonry wall, average condition.
- Ceiling - Paint on plasterboard on ceiling joists, average condition.
- Painted timber architraves, painted timber horizontal boards under sills, all average condition.
- Door D103 - Described under room R101.
- Fireplace - Modern sandstone fireplace on north wall (Photo 26), reasonable condition.

Photo 26. Modern fireplace
